National Register of Historic Places Registration Form

historic name Slaten - LaMarsh House
other names/site number Potter's House Gallery

street & number 25 East Main Street [N/A] not for publication
city or town Grafton [N/A] vicinity
state Illinois code IL county Jersey code 083 zip code 62037

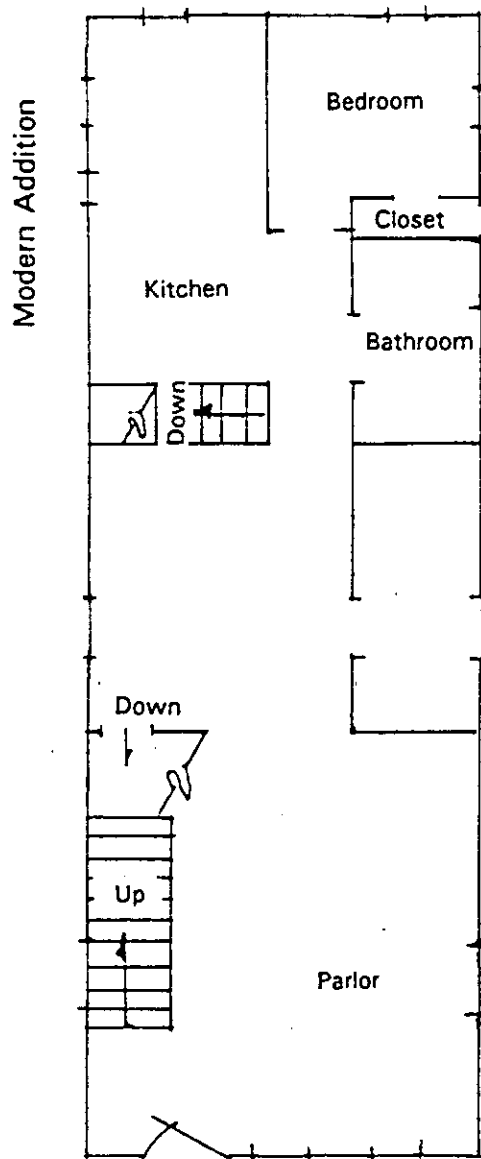
Floor Plan Sketch

Not to Scale

The interior of the Slaten - LaMarsh House was damaged in the 1993 flood, but still retains its integrity. The first story is subdivided into two rooms with a large "L"-shaped main room and a smaller room located in the southwest corner; the dimensional lumber of the dividing walls is exposed, without wall covering. Wide pine flooring covers the entire floor with the plates of the dividing walls laid directly on the flooring.

Narrow replacement stairs are located on the east side near the front entry and run from the basement up to the upper story. The upper story space has been divided into two small rooms, while the basement area is one large space.

The rear addition contains a modern bathroom and bedroom with large closet along the west half. The east half contains a "U"-shaped modern kitchen and an eating area. Open stairs to the basement are located next to the original house.
